**EVALUATION OF NON-DESTRUCTIVE TECHNIQUES FOR
CORROSION DETECTION IN CONCRETE EXPOSED
TO A MARINE ENVIRONMENT**

**Prepared in cooperation with the State of Hawaii Department of Transportation,
Highways Division and U.S. Department of Transportation, Federal Highway
Administration**

Research Report UHM/CEE/05-04

May 2005

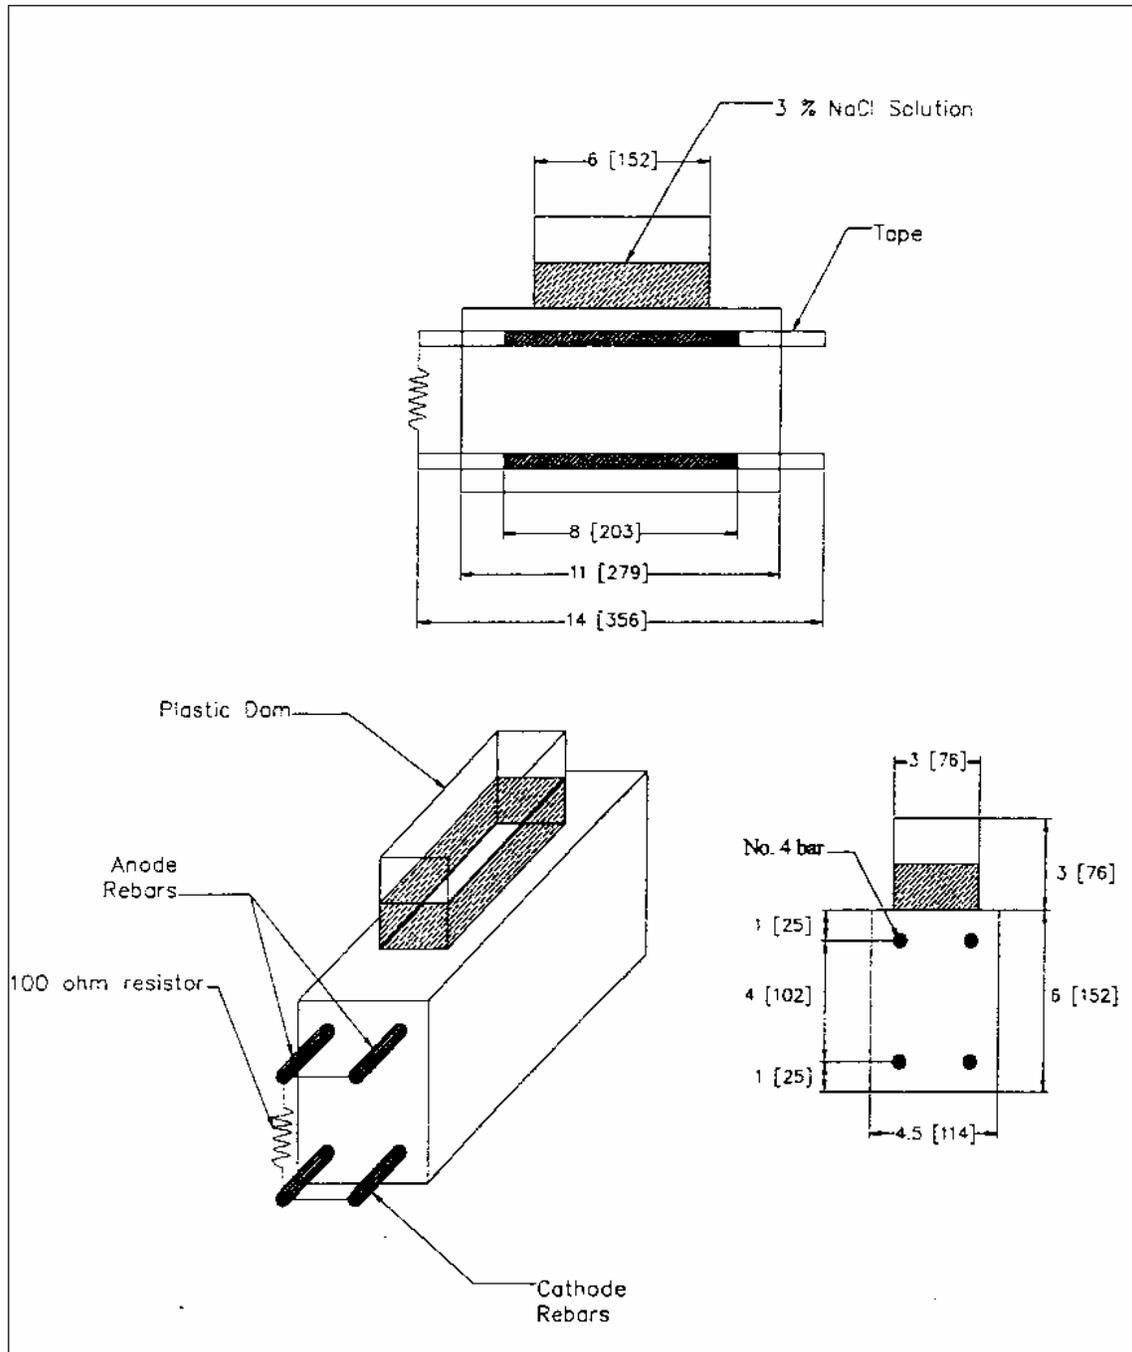
Figure 3.1: Details and dimensions (inch (mm)) of beam specimens

The specimens were prepared according to ASTM G 109-92 guidelines. A 10% (by weight) sulfuric acid bath was used to pickle the bars. The reinforcement was dried and then wire brushed. Ends of the bars were taped for three inches from each end using non-conductive electroplater's tape. When the ends were taped there were 8 inches of exposed length. The tape was used to protect the steel from corroding during curing. The bars were inserted into molds and concrete were cast and cured. After stripping the form work, the sides were sealed with epoxy coating. Each specimen is 11 x 6 x 4.5 inches in size Figure 3.1.

A plastic dam was sealed to the top of the specimen to hold approximately 400mL of a 3% NaCl solution. The plastic dams are 3 in. (76 mm) wide, 6 in. (150 mm) long, and 3 in. (76 mm) tall. Silicon glue was used on the outside of the dams to seal the top surface of the concrete to the bottom of the dam. The four vertical sides and the top surface outside of the dam were sealed with epoxy. The concrete inside the dam and the bottom of the specimen were the only surfaces not sealed with epoxy. Ground clamps were attached to each bar and a 100-ohm resistor that connects the bottom and top bars. The specimens were supported on two strips of wood or something comparable at least .5 inches thick. These supports allowed air to flow under most of the specimen. The specimen was ponded for two weeks at $23 \pm 3^{\circ}C$ ($73 \pm 3^{\circ}F$) with the salt water solution. The relative humidity fell into the range of $50 \pm 5\%$. A transparent plastic covering was placed over the dams to minimize evaporation. After two weeks the water was vacuumed off and samples were allowed to dry for two weeks. The cycle was repeated until failure. A high impedance voltmeter (at least one Mohm) was used to monitor the specimens. The current was measured every four weeks (one cycle), the first measurement occurred one week after the first introduction to the salt water solution. The specimens were monitored until the average macrocell current of the specimens is $10 \mu A$ or greater, and at least half the samples showed macrocell currents equal to or greater than $10 \mu A$. The monitoring was continued for three complete cycles to ensure the presence of enough corrosion for visual inspection.

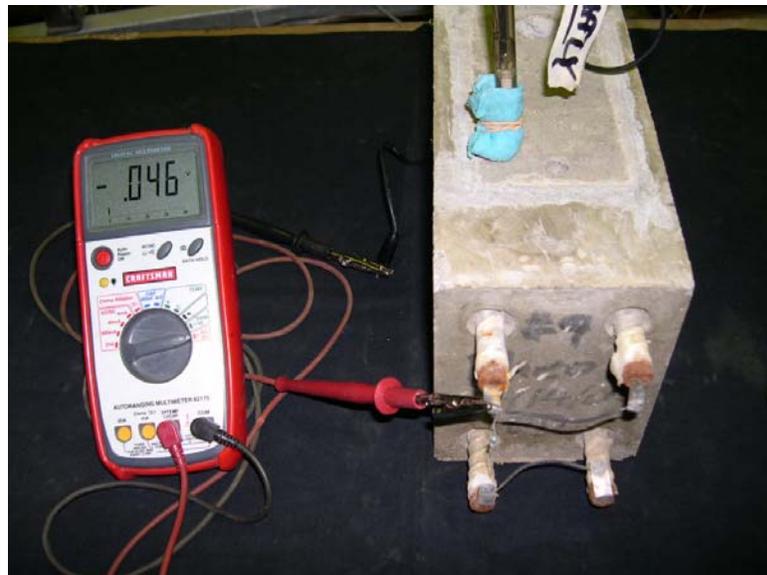
Figure 3.2 : Points where half cell reading were taken (left), half cell set up (right)

The half cell measurements were taken with a calomel reference electrode. Six readings were taken per specimen. Three readings were taken over each of the top reinforcing bars at approximately 3 in., 5.5 in., and 8 inches from the front of the specimen (Figure 3.2). The values were recorded and later converted to a copper-copper sulfate equivalent. The conversion to convert calomel reference electrode to copper-copper sulfate is to add -0.077 mV to calomel values (Corrosion Doctors 2004).

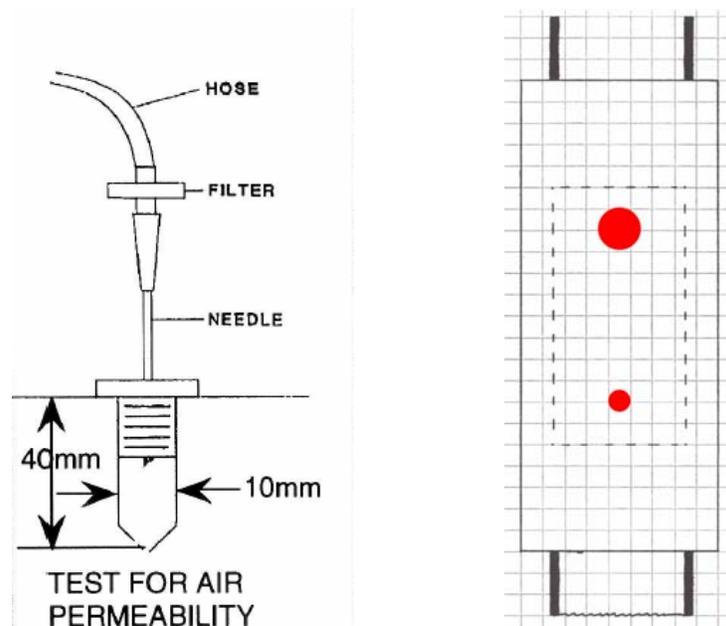
Figure 3.4 : Air permeability set up (left), approximate points were air permeability (small dot) and chlorides (big dot) were taken (right)

To perform the air permeability test a 0.39 in. (10 mm) diameter hole was drilled to a depth of 1.58 in. (40 mm) on the top surface of each specimen. The loose dust was blown out of the hole and a molded silicon rubber plug was inserted into the hole. The top flange of the plug was secured flush to the concrete surface. Then, a needle was inserted through the plug so that the tip of the hollow needle just protrudes through the bottom of the plug. The air permeability test was performed by vacuuming the air out of the void through the needle (Figure 3.4). The air permeability test records the time it takes for the pressure in the hole to change from -7.98 psi to -7.25 psi (-55kPa to -50 kPa). The hole was drilled in the middle toward the front of the specimen. The chloride sample was drilled at the opposite end of the ponding area as shown in Figure 3.4. A Poroscope Plus was used in performing the air permeability tests (P-6050, James Instruments Inc). The testing process followed the operating instructions for the instrument.

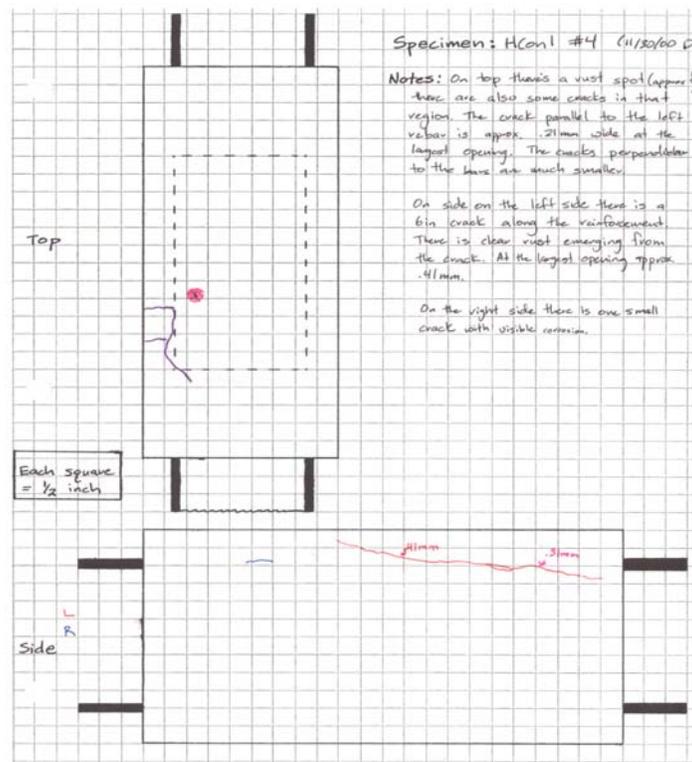
Figure 4.1 : Exterior visual inspection

A thorough visual inspection was conducted of each specimen to record cracks and voids, while including side notes for future reference. Photographic records were obtained at the top surface and sides of each specimen, particularly for those with significant visual damage. The number of pictures taken depended on the amount of damage that appeared on the specimen. Figure 4.1 shows a typical specimen exterior visual record.

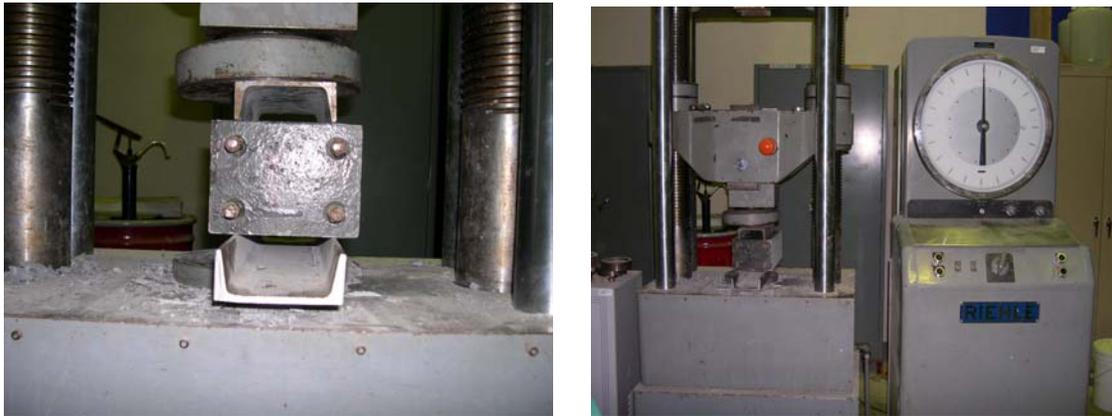
Figure 4.2 : Specimen splitting

Before the specimens were split, the top reinforcing bars and top cover were labeled to avoid confusion over orientation of the specimen pieces. The intent was to examine the interface between the steel and the concrete on both the top and the bottom of the reinforcing bars to identify corrosion and any likely causes of this corrosion. The specimens were carefully split using two channels in a compression machine (Figure 4.2). The load was increased until the specimen broke in tension along the top reinforcement layer.

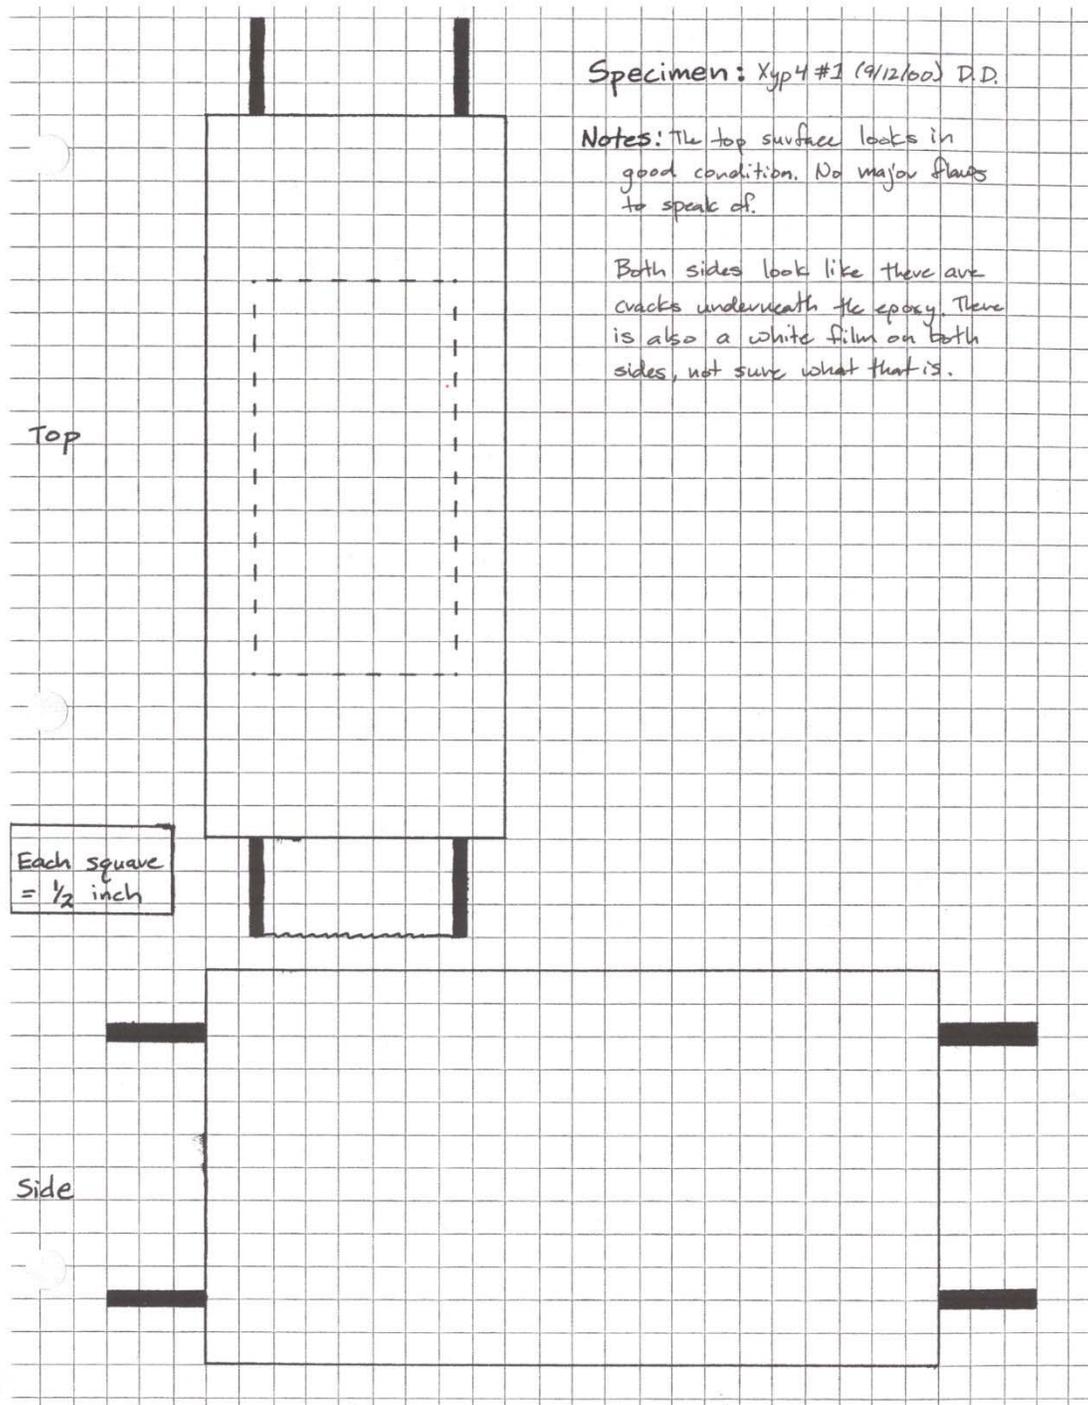
Figure 4.3 : Exterior visual inspection of Xyp4 #1

The first specimen was a fairly clean sample. The external visual inspection of Xyp4 #1 is shown in Figure 4.3. The external inspection revealed cracking underneath the epoxy on the side of the specimen. In the interior inspection, there were a number of voids located on the bottom section. The majority of the voids occurred under the left reinforcing bar (Figure 4.4). The examination of the bars (Figure 4.5) revealed a small area of corrosion on the bottom of the left bar in the approximate area where a large void on the left side of the bottom piece was located (Figure 4.6). This particular specimen showed initiation of corrosion but not yet at a critical point. The specimen was removed after 31 cycles and both electrical readings fell into the lower ranges. The measured current was less than $2 \mu A$ and the half cell potential values indicated a 10% probability of corrosion.

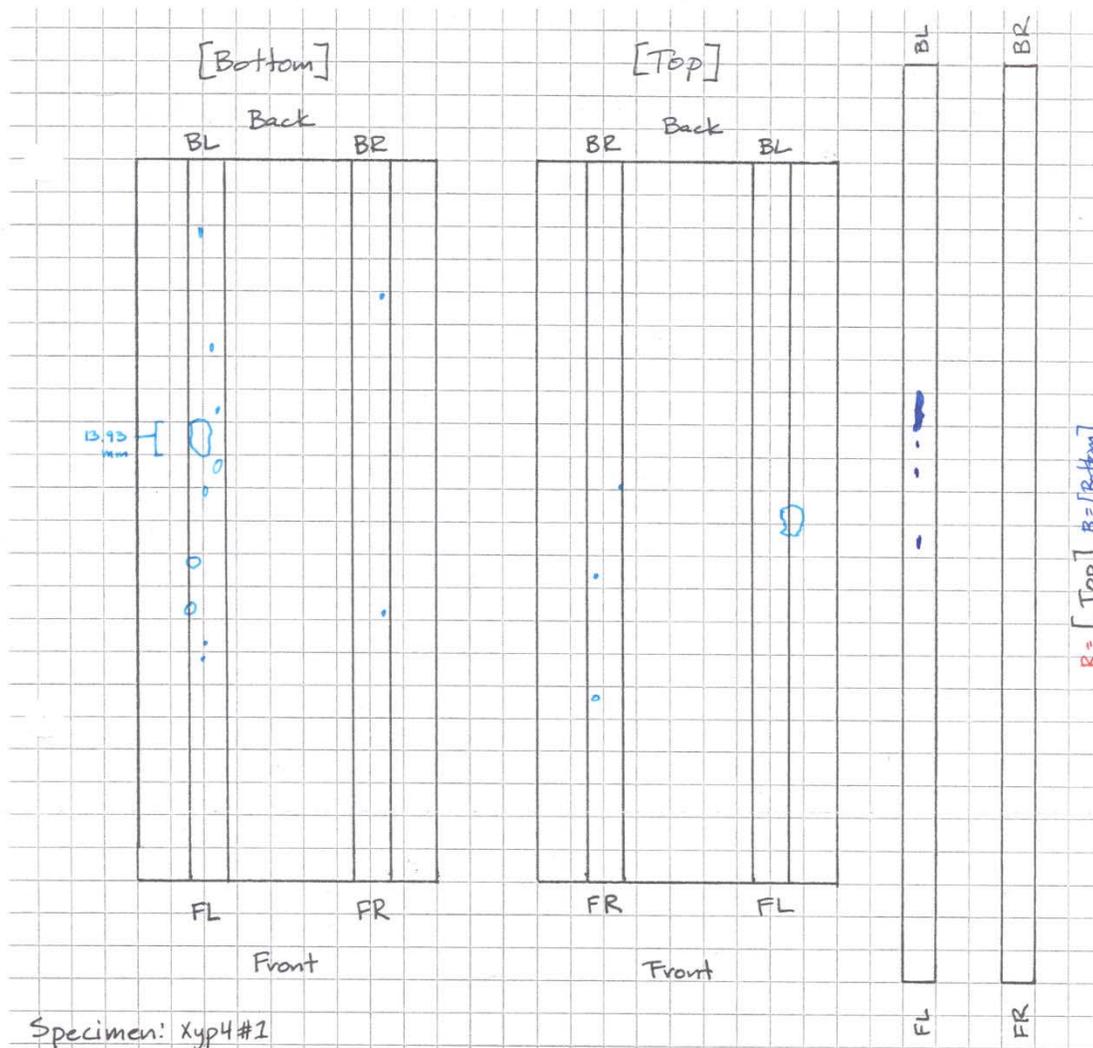
Notes: The top and bottom pieces are clean. The left side of both have some large voids. Only the left bar on the bottom is showing pits of orangish corrosion. The right bar is clean. Crystals and tiny voids.

Figure 4.4 : Interior inspection of Xyp4 #1

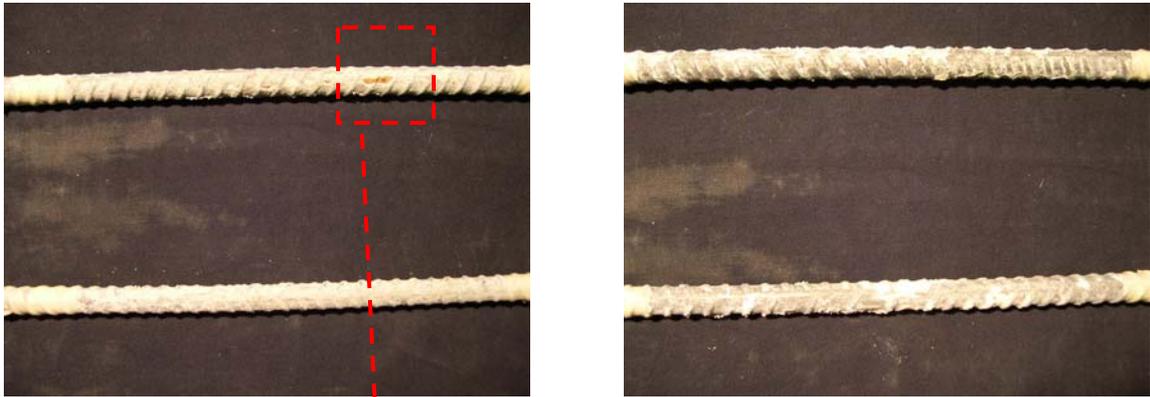
Figure 4.5 : Bottom (left) and top (right) surfaces of top reinforcing bars

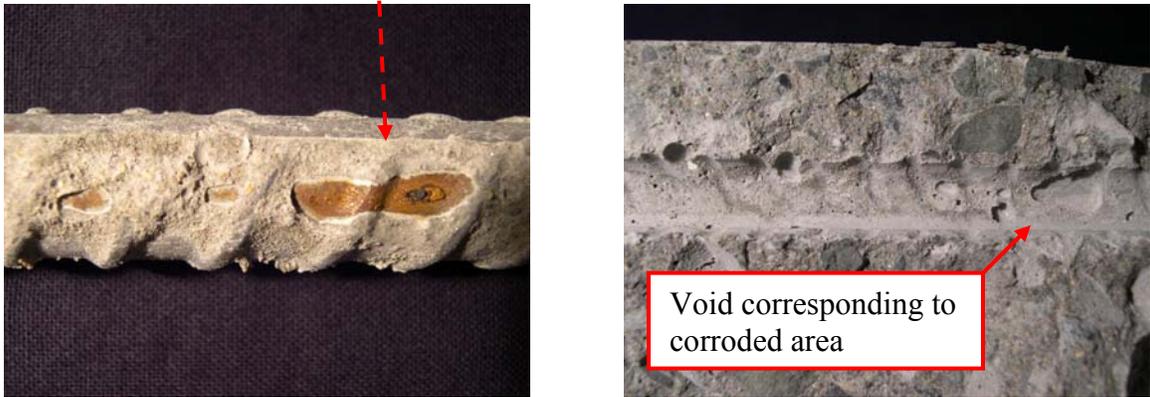
Figure 4.6 : Bottom of left reinforcing bar and corresponding concrete surface

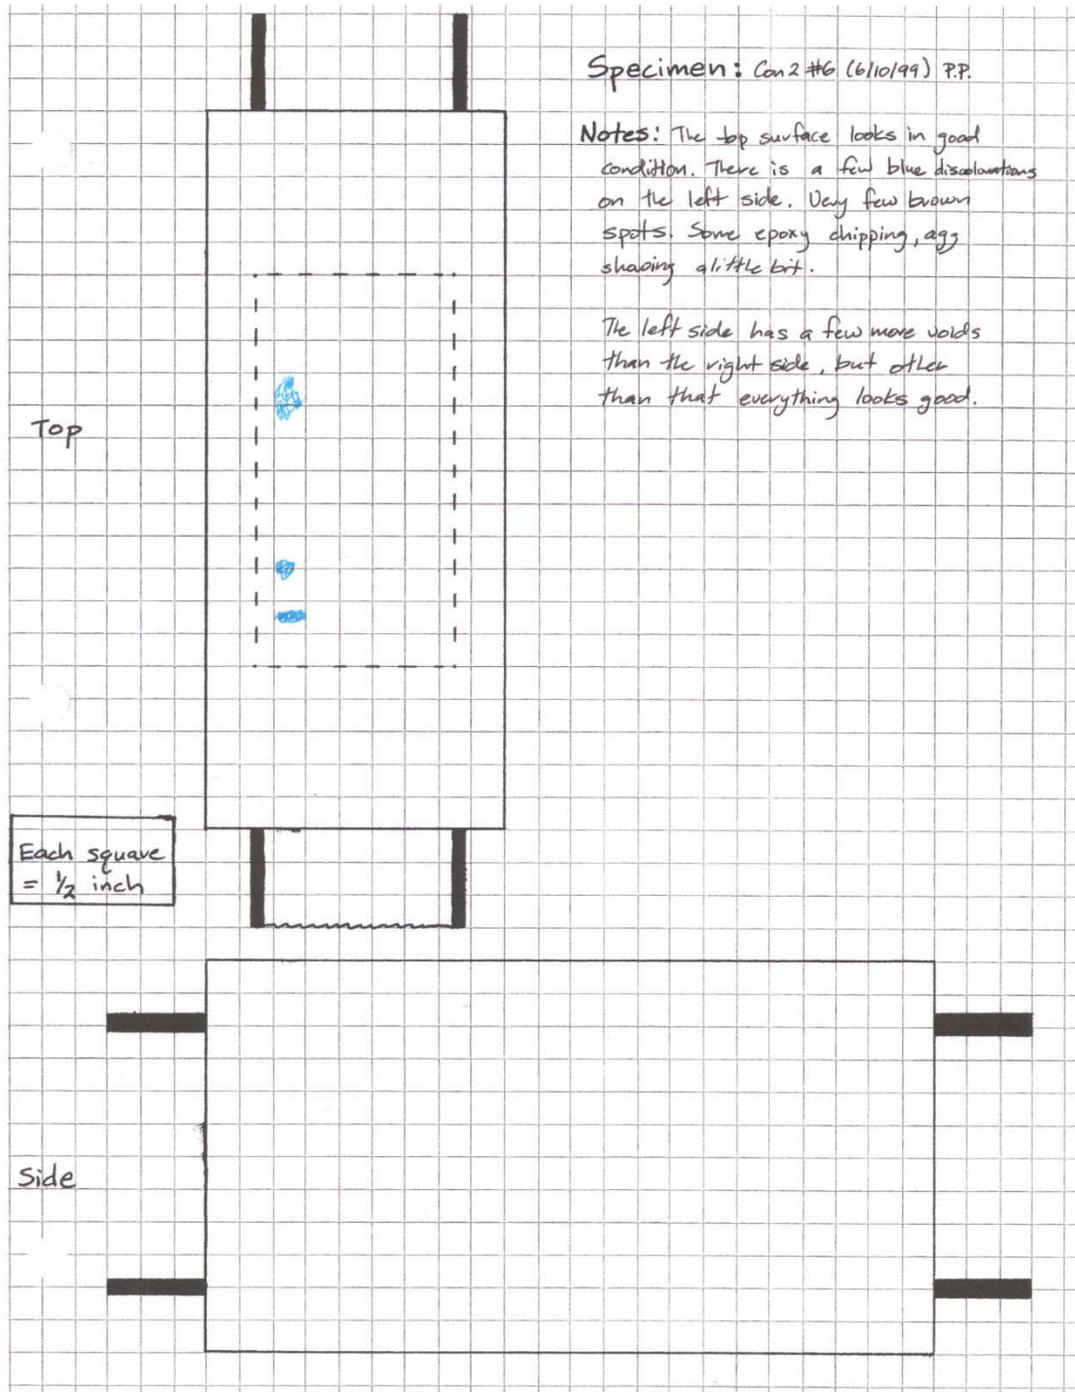
Figure 4.7 : Exterior visual inspection of Con2 #6

Figure 4.9 to Figure 4.12 show examples of the corrosion occurring on both bars. Figure 4.9 shows overall views of the bottom and top view of both bars. Figure 4.10 shows the bottom of the left bar and a close up of a corrosion pit. Figure 4.11 and Figure 4.12 show close-ups of two different areas located on the bottom and inside edge of the right reinforcing bar. Figure 4.13 shows the transfer of corrosion on the bottom piece. The mixture of Con2 #6 had a water-cement ratio of 0.45 and had no admixtures to protect against corrosion. There were no cracks on the outside surface to indicate localized corrosion. There were voids on both sides of the bottom piece that appeared to contribute to the initiation of corrosion. The electrical current measured for Con2 #6 was less than $2 \mu A$ and the half cell potential readings fell into the uncertain region. The electrical results did not seem to characterize the specimen as failed but the visual results showed extensive corrosion.

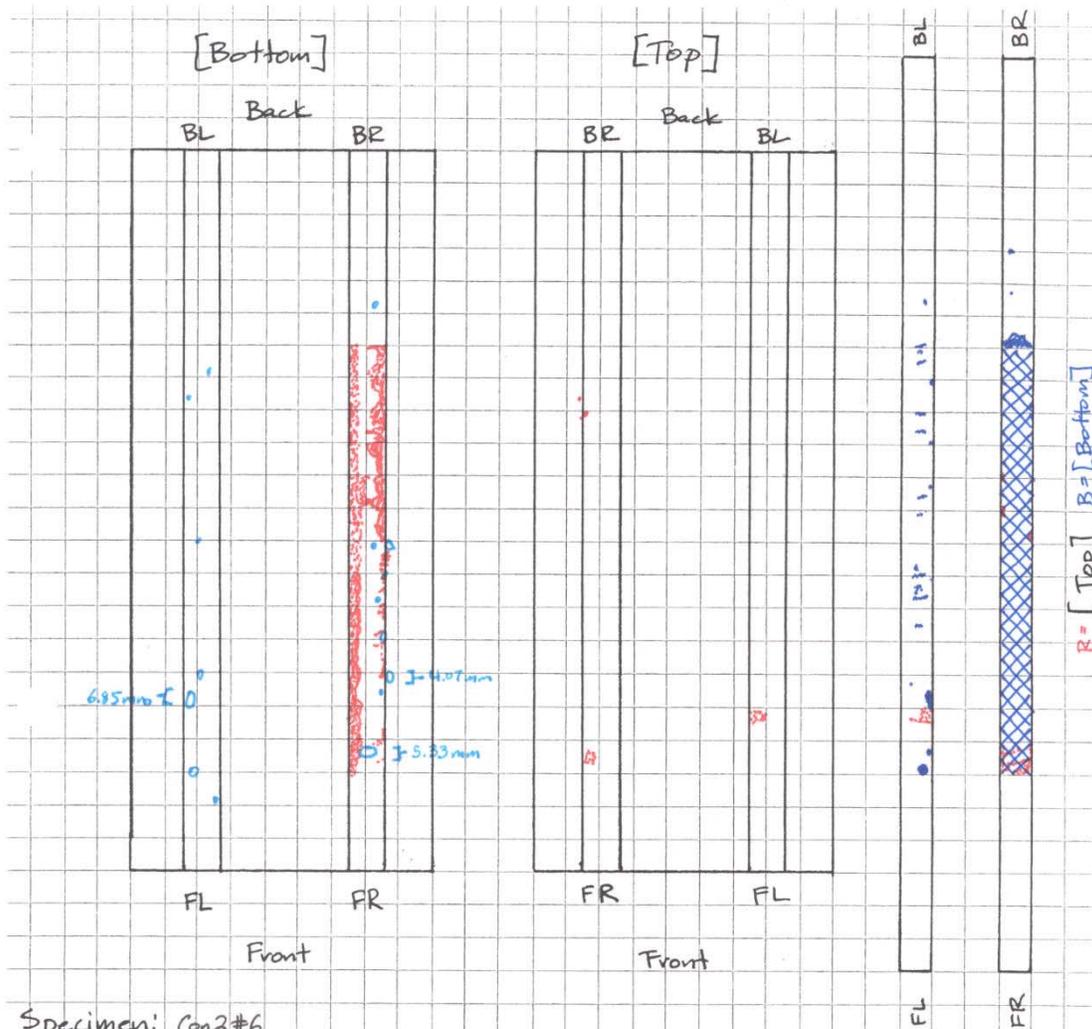
Specimen: Con2 #6

Notes: The bottom piece has a good variation of voids on both sides, but only the right side has corrosion. Toward the front it's light brown, as you move to the back it gets darker. The top piece has a few light spots. The left (bottom) bar has some pitting, light orange coloring. The top of the right bar has some light haze at the front face, the bottom is almost completely covered.

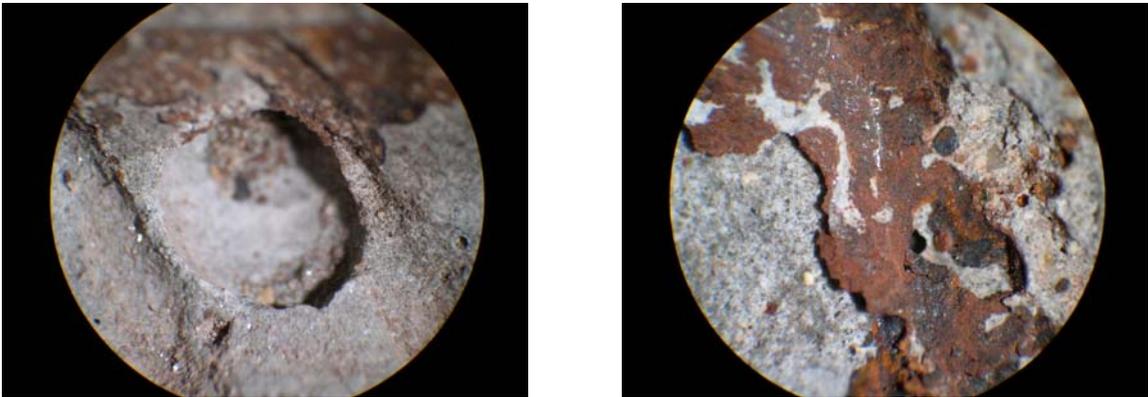
Figure 4.13 : Bottom piece, right side, corrosion on concrete (left) x22.5 (right) x45

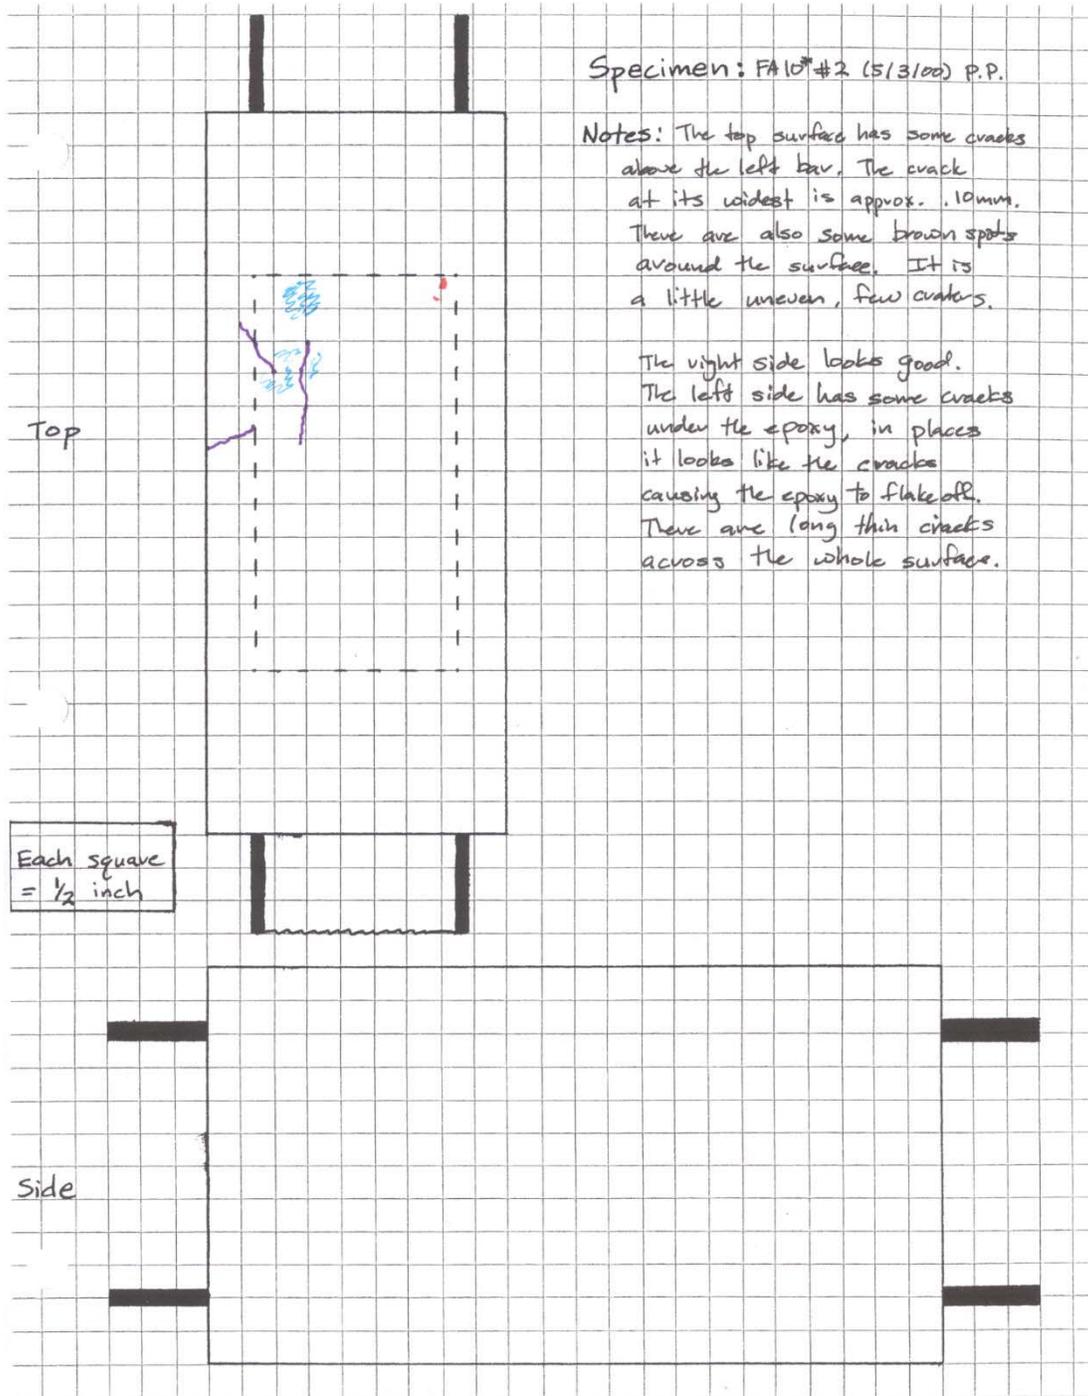
Figure 4.14 : Exterior Inspection of FA*10 #2

The exterior inspection of this specimen had cracks on the left of the top surface (Figure 4.14 and Figure 4.17). The left side of the specimen also had some small cracks underneath the epoxy (Figure 4.14). The interior inspection showed that the area where the cracks were located corresponded to significant corrosion on both the top and bottom surfaces of the left bar (Figure 4.15). The right bar had some corrosion along the bottom surface. Figure 4.16 shows the top and bottom of the reinforcing bars. Significant corrosion was noted on the left bar as shown in the magnified images in Figure 4.17 and Figure 4.18. In Figure 4.17, a close-up of the cracks can be seen on the top surface. Figure 4.19 shows the left side of the bottom piece and some of the corrosion toward the inside of the specimen. This specific mixture contained a water to cementitious material (cement + fly ash) ratio of 0.45 with 10% fly ash replacement of cement. Both electrical tests provided suspicions of corrosion. The macrocell current measured over $10 \mu A$ and the half cell potential gave readings indicating 90% probability of corrosion.

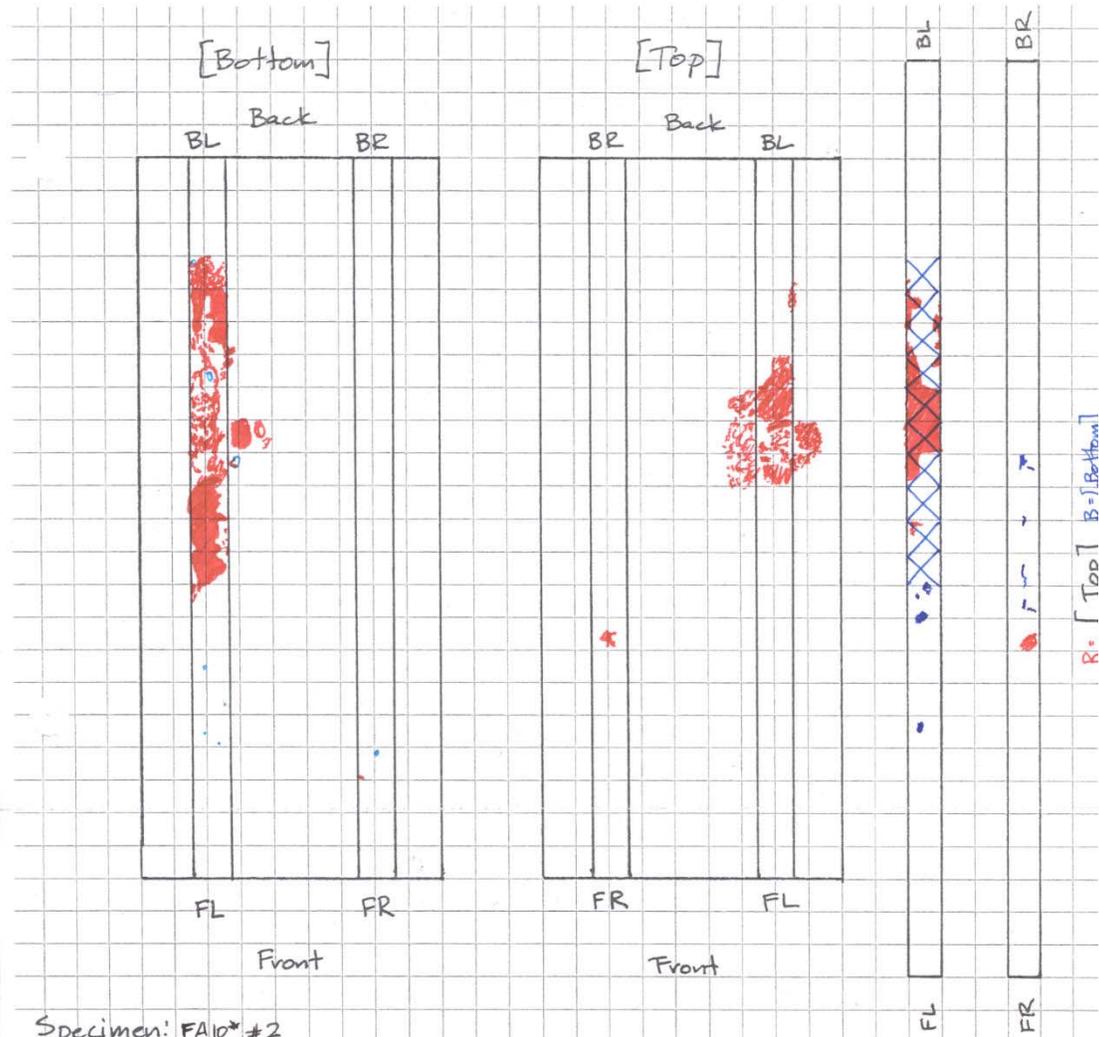
Specimen: FA10* #2

Notes: The bottom piece has a few tiny voids. On the left side there is dark brown, and a few black spots (tiny). There is one big spot on the inside of the left bar indentation. The top piece has a large area of corrosion on the left side, it goes to the inside as well as the outside edge. It is dark brown and orange in color. The top of the left bar is black with a few more pits toward the back. The bottom is fairly well covered in brown and black spots, from the middle toward the back. The right bar has one spot on the top (black). The bottom has a few light pits, light orange.

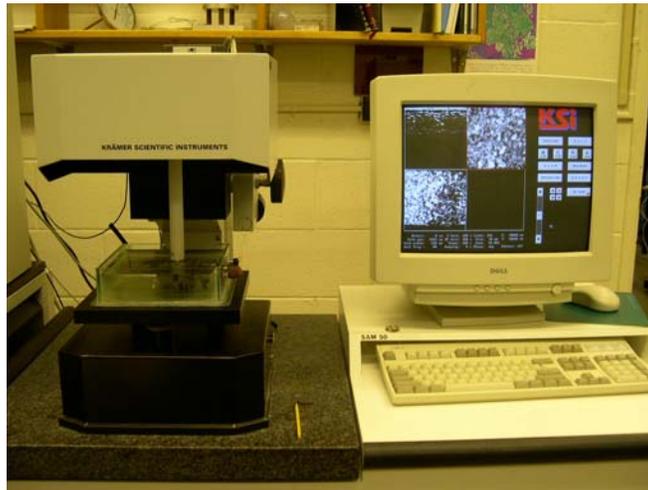
Figure 5.1 : Scanning Acoustic Microscope

The acoustic microscope used in this study is part of the Department of Geophysics material identification laboratory. The acoustic microscope used in this study was a Kramer Scientific Instrument SAM 50 (Figure 5.1).

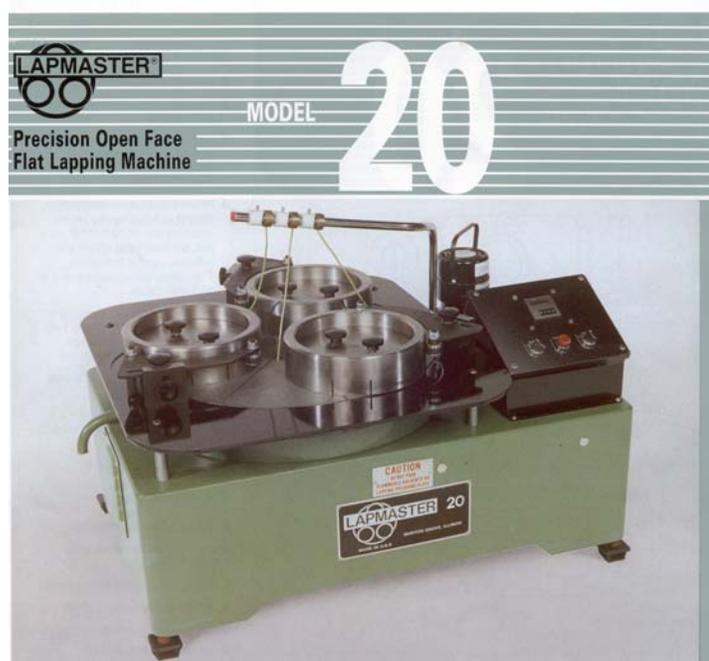
Figure 5.4 : Lapmaster

they were square. The first objective was to remove the roughness caused by the saw cuts; the second was to remove cover concrete so that the surface was close to the reinforcing bar. After this was done, the specimens were labeled and were ready for the acoustic microscope. It is possible that the polishing process could affect the imaging process.

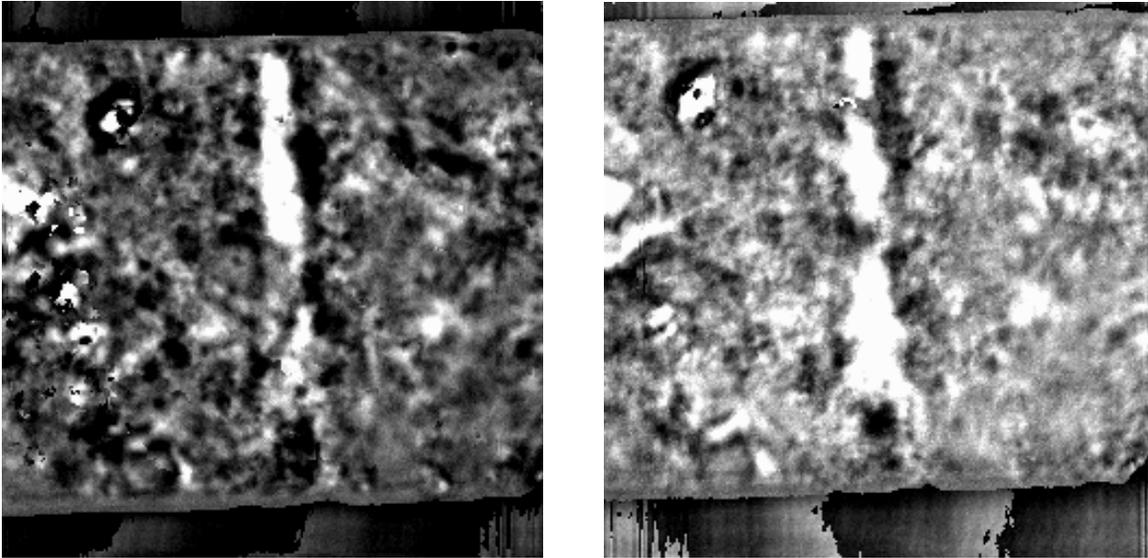
Figure 5.8 : C – Scan images (Zinin et al, 2004)

The pictures from acoustic microscopy were not very helpful. The hope of this inspection was to get an image of the extent of the corrosion on the bar. From the images the extent of what is seen is uncertain. There are various reasons why SAM did not provide better images. One was because sound travels poorly through concrete. The SAM equipment used in this study was not sensitive enough in distinguishing the difference between cement paste and aggregate. Other reasons include inadequate resolution, high frequency range, and small wave lengths.

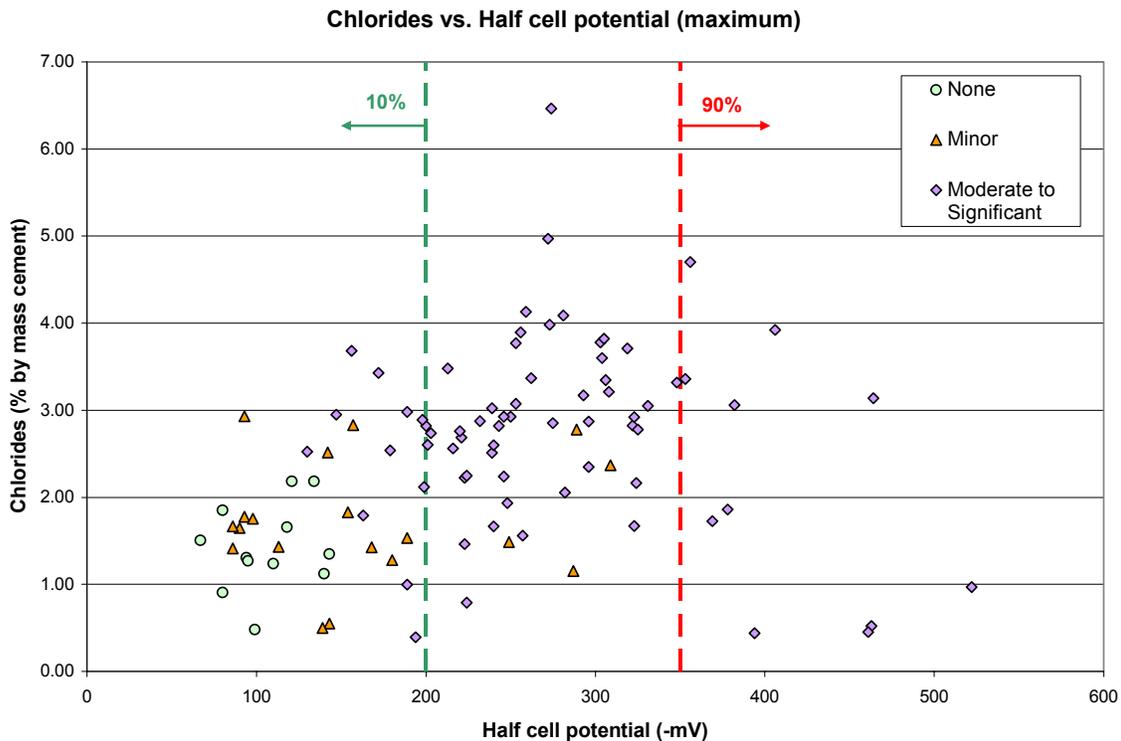
Figure 6.1 : Chlorides vs. Half cell potential

Figure 6.1 below shows chloride concentrations (% by mass of cement) versus the maximum half cell potential value measured on each specimen. The points on the figure are color coded with the same, light blue indicating no corrosion, orange indicating minor corrosion, and purple indicating moderate to substantial corrosion. The figure also indicates the limits for the probability of corrosion from the half cell potential readings.

The specimens with no corrosion all fell in the 10% probability corrosion area and the majority had less than 2% chloride content. Most of the specimens with minor corrosion fell into the 10% probability range and had less than 3% chlorides. The specimens with substantial corrosion were spread out all over the figure. The majority of the specimens with substantial corrosion were in the uncertain half cell range. Values for specimens with substantial corrosion fell into every single category of chloride content and half-cell range, making it difficult to draw an encompassing conclusion. Figure 6.1 seems to show the lower limit of guaranteed substantial corrosion. Substantial corrosion always occurred when the chlorides values were over 3% or the half-cell readings were in the 90% probability range.

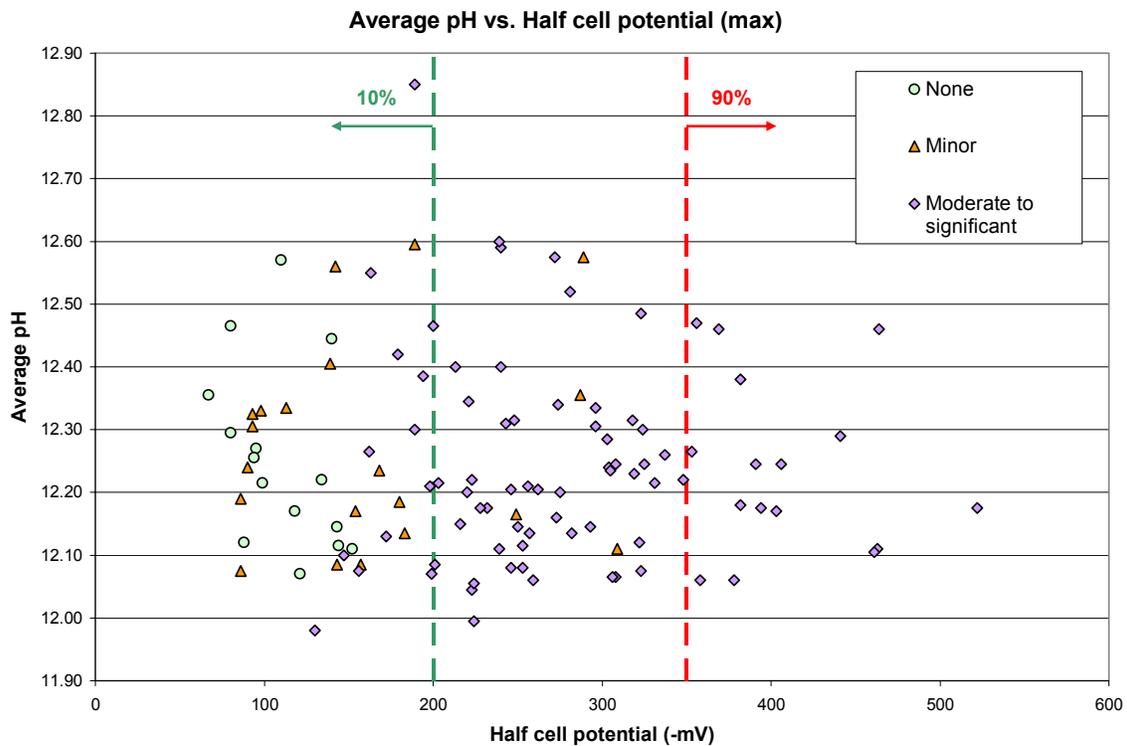
Figure 6.2 : Average pH vs. Half cell potential

The pH appears to be negligible in determining when corrosion is a factor. Knowledge of the pH does not appear to provide an indication of the likelihood of corrosion and chloride content. However, a very small range of pH values were observed in this study.

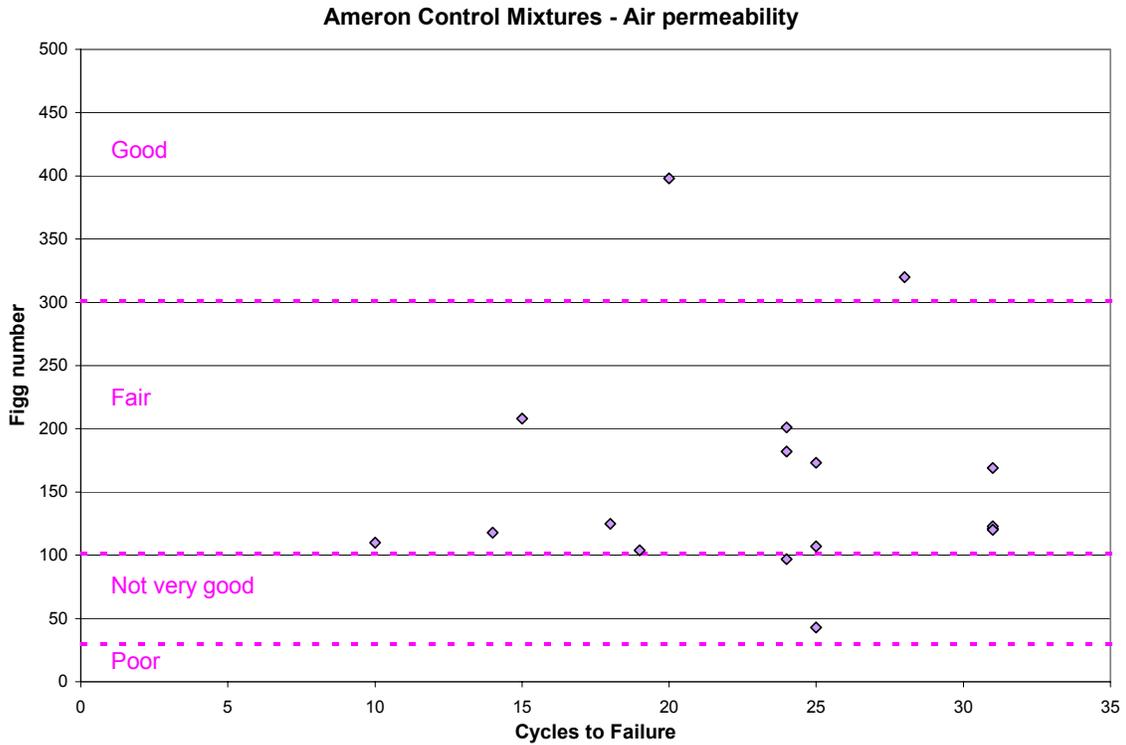
Figure 6.4 : Ameron Control – Air permeability

Figure 6.4 plots the Ameron Control mixture Figg numbers versus the number of cycles to failure. The graph shows a slight trend to increasing cycles to failure as the Figg number increases, however there are a number of specimens with very low Figg numbers that took over 20 ponding cycles to reach failure. One would expect the number of cycles to failure to increase as the Figg number increases.

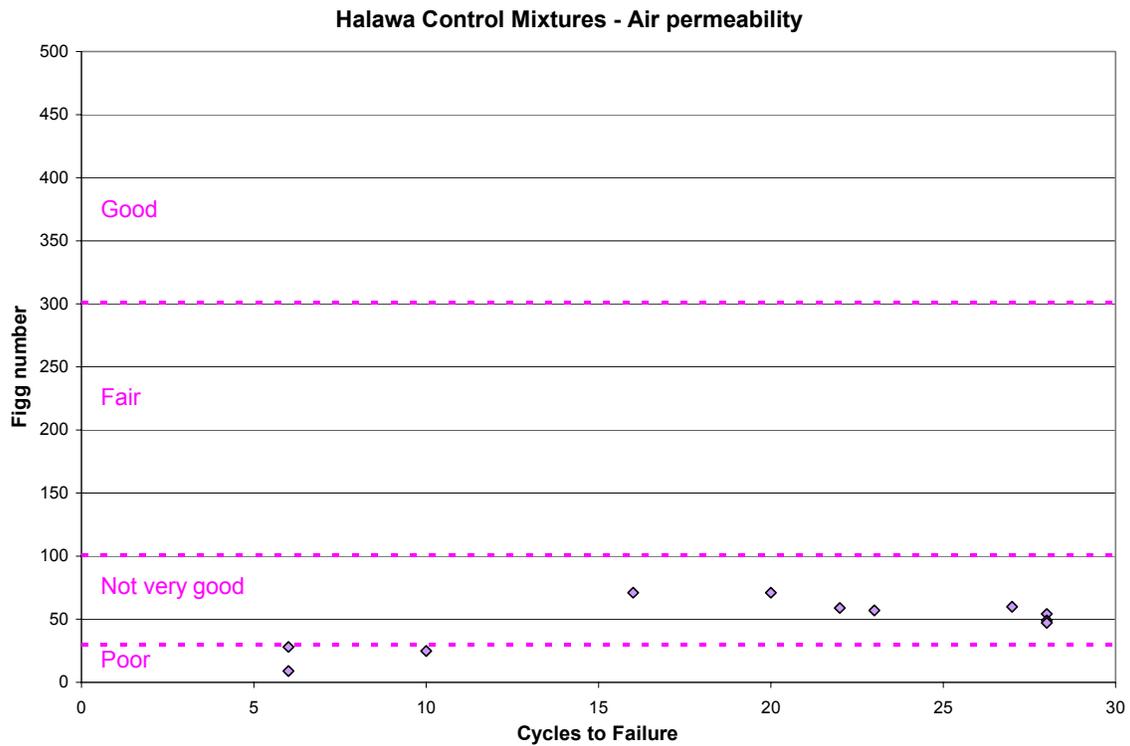
Figure 6.5 : Halawa Control – Air permeability

Figure 6.5 plots the Halawa Control mixture Figg numbers versus the number of cycles to failure. The graph shows a trend of a higher Figg number (less permeability) corresponding to a greater number of cycles until first corrosion. One concern about the Halawa control mixtures is the low values of the Figg numbers. All of the values fall into either the “not very good” or “poor” range.

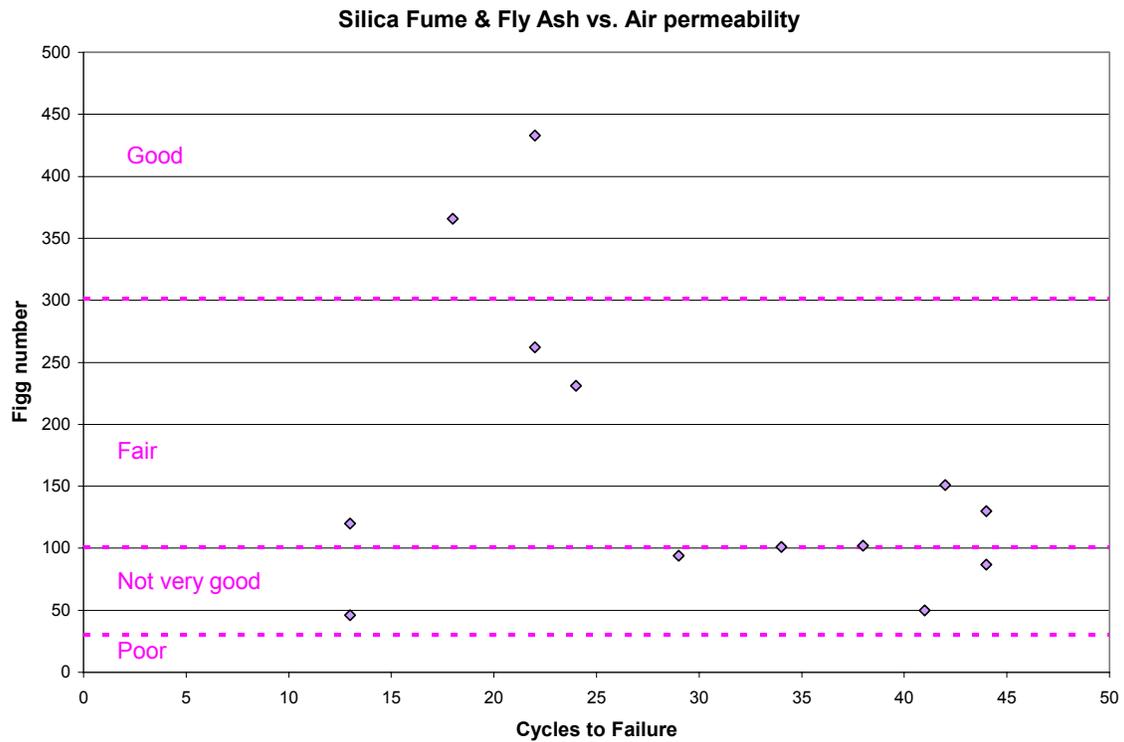
Figure 6.6 : Silica Fume & Fly Ash – Air permeability

Figure 6.6 shows how silica fume and fly ash specimen air permeability varied against the number of cycles to failure. From the plot there is a slight trend of increased permeability (low Figg number) and a longer of time until the specimen measures $10 \mu A$. This is not what was expected, but the correlation was not very strong.
